URBAN ISLAND

Maide Ulusoy	10/12/2020
000494475	BA2 IRAR
1	ARCH-H200

Planche technique

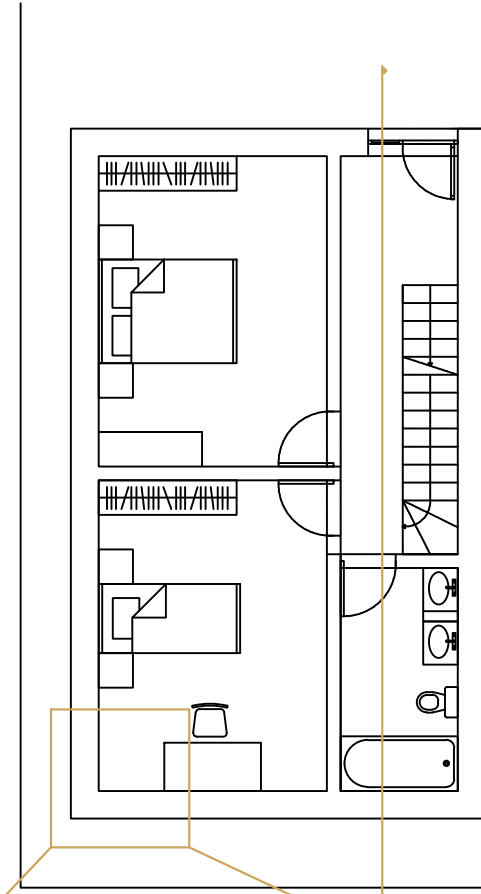
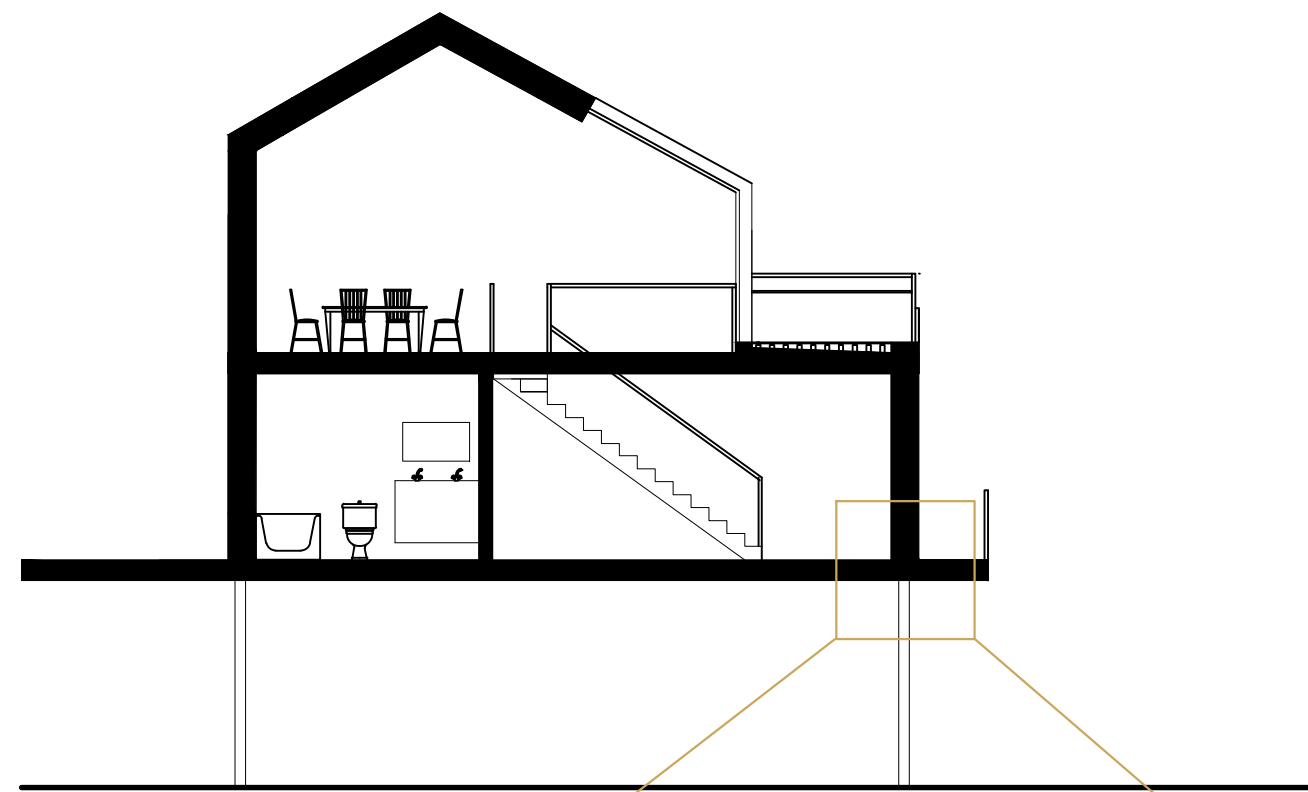
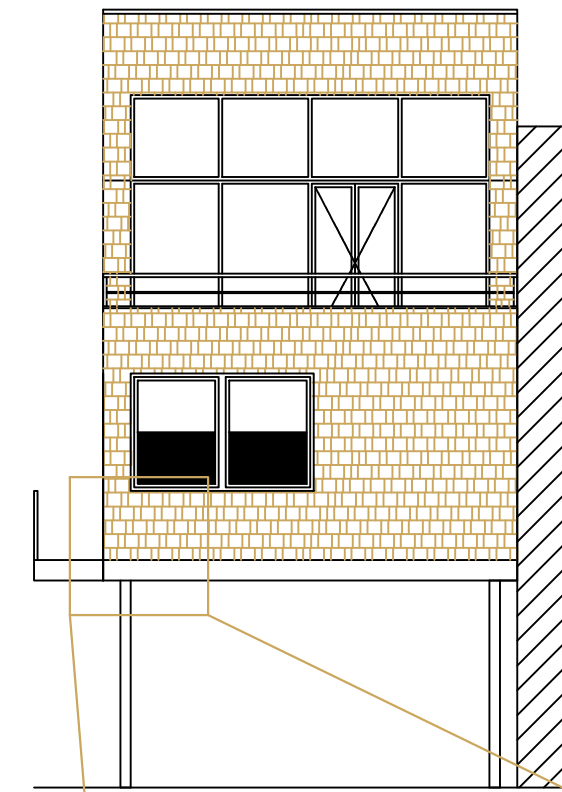
1. gyproc
2. pare-vapeur
3. isolation souple
4. plaque OSB cirée et huilée
5. étanchéité
6. shingles en bois de cèdre
7. lattes de bois de cèdre
8. poutre en bois
9. colonne en bois
